# When a spark suddenly flash over

Accident in synthesis plant – electrostatic discharge identified as cause of ignition

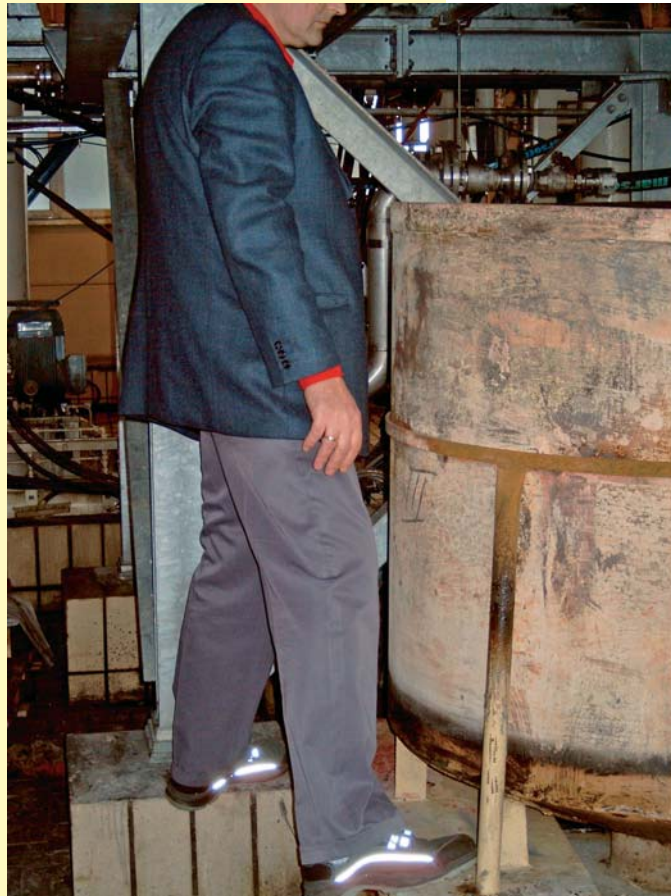
Figure 1: Re-constructed: this is how the employee was standing when the accident occurred

As the bulk material fills the wheeled container, a heap of bulk material forms under the end of the hose. To better utilise the capacity of the wheeled container, the employee attempted to distribute the heap of bulk material using his hands. For this purpose he climbed onto the steelwork for the bottling plant, held onto a steel member with the left hand, bent over the wheeled container and smoothed the heap with the other hand.

He then reached to the hose and moved it in a circle to prevent a new heap of bulk material forming. During this process a flash flame occurred. The employee suffered burns to the face and arms.

The transport of the solids in pipes or hoses always involves the separation of surfaces. Here electrical charges occur that remain on the surfaces of insulated objects or substances for some time. As a measure against electrostatic charging, normally conductive plant components are used and earthed. Although the hose used here was dissipative, it was not continuously earthed during assembly. Due to the lack of contact to earth, it was not possible to dissipate the charge that occurred, and the surface became electrostatically charged. As the employee's right hand approached the hose, a spark discharge occurred. As he was holding onto a steel girder with the left hand, he acted as an earth.

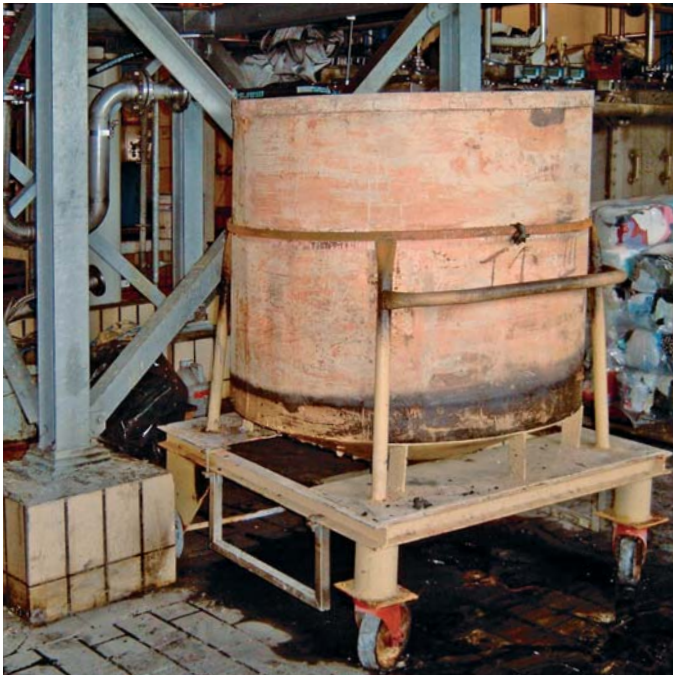
Figure 2: Old transport container

All fixed installed components of the assembly and pipes were connected together conductively and earthed. Only the transport containers and the hose were not included in the equipotential bonding. The centrifuge was also inertized using nitrogen. All essential production process parameters come together in the measuring station.

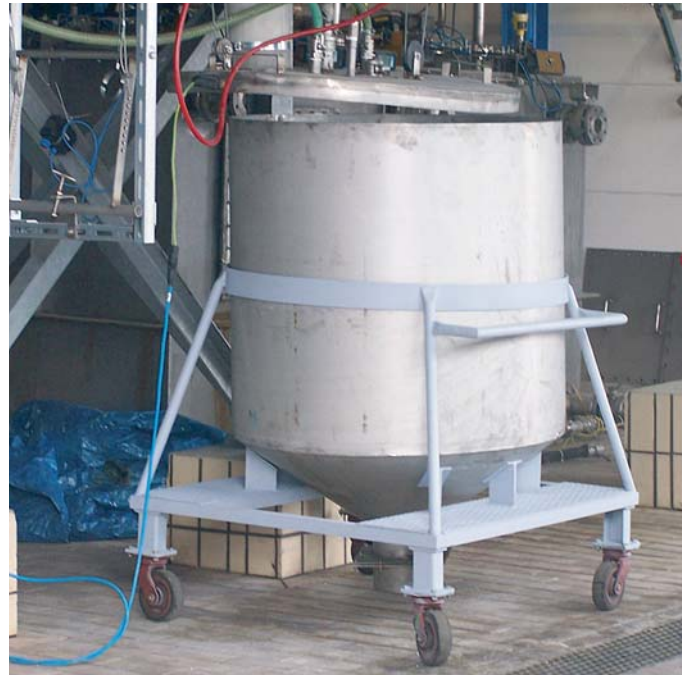
Figure 3: New transport container

The company now uses closed wheeled containers to prevent the escape of toluene vapours during emptying. The dissipative emptying hose and wheeled containers are included in the inertization. The connection between the centrifuge outlet, hose and wheeled container, and earth potential is monitored.
